**Steel
Hub**

Where Challenge
Meets Solution

Technical Evaluation of two Celsa Steel Plants in Europe for a Private Investment Company

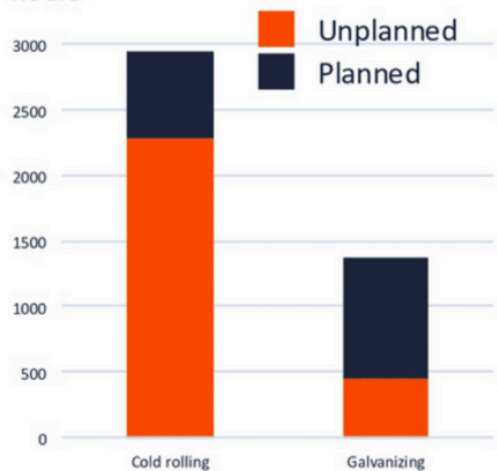
Total production stoppage time
hours

- Diagnose the root causes of frequent steel breakages and stoppages in the 20-Hi and 6-Hi rolling mills, and implemented customised solutions to improve their productivity and reliability.
- Conducted a deep-dive analysis of quality and production reports to segment areas with the highest occurrence of production stoppages and steel breakages.
